RE:	Insured:	Chef Ekrem's Mediterranean
	Claim Number:	[REDACTED]
	Policy Number:	[REDACTED]
	Loss Date:	01/14/2021
	Location of Loss:	1781 Newport Blvd Ste C, Costa Mesa, CA
	Subject:	Important Claim Information

SPC 9368-01

**Subject: LIMITED ENGINEERING REVIEW
DAMAGE EVALUATION**
Insured: Ekrem Ozturk
1781 Newport Boulevard, Suite C
Costa Mesa, CA 92627
Claim No. [REDACTED]
Date of Loss: January 14, 2021

LEAK DETECTION INSPECTION REPORT

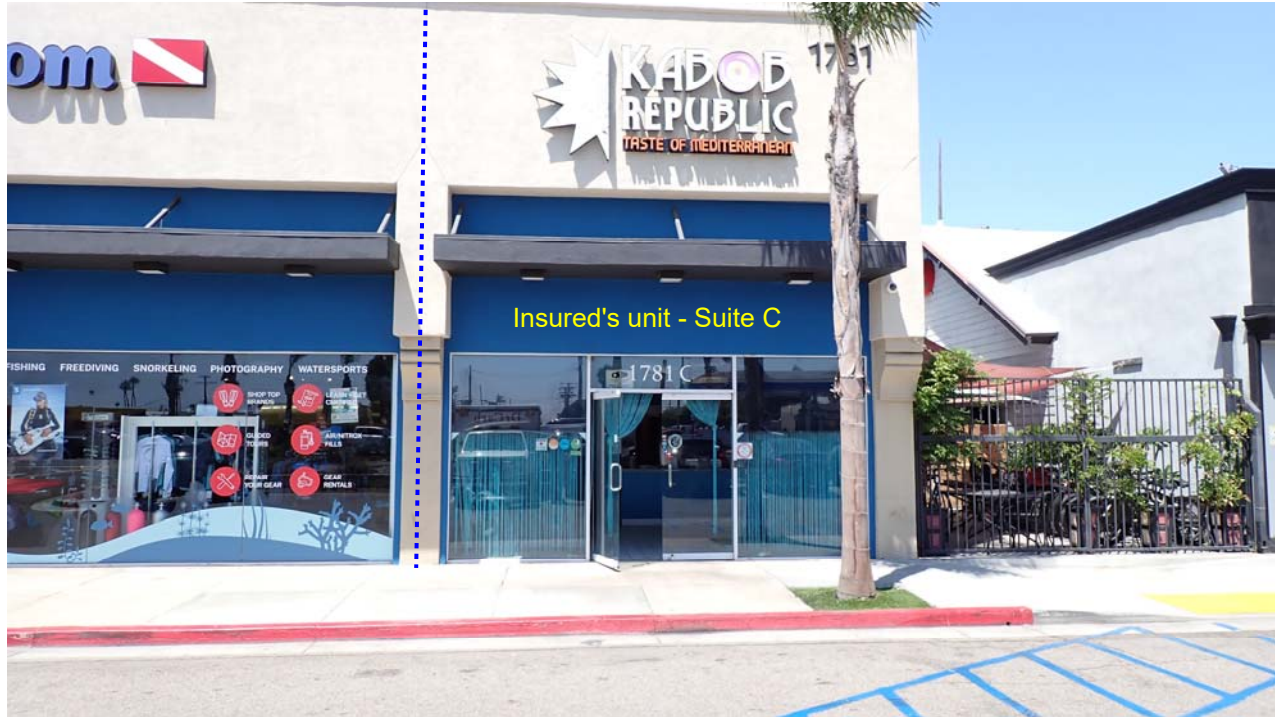
Photo 1: A front view of the unit, which occupies approximately one-third of the building.

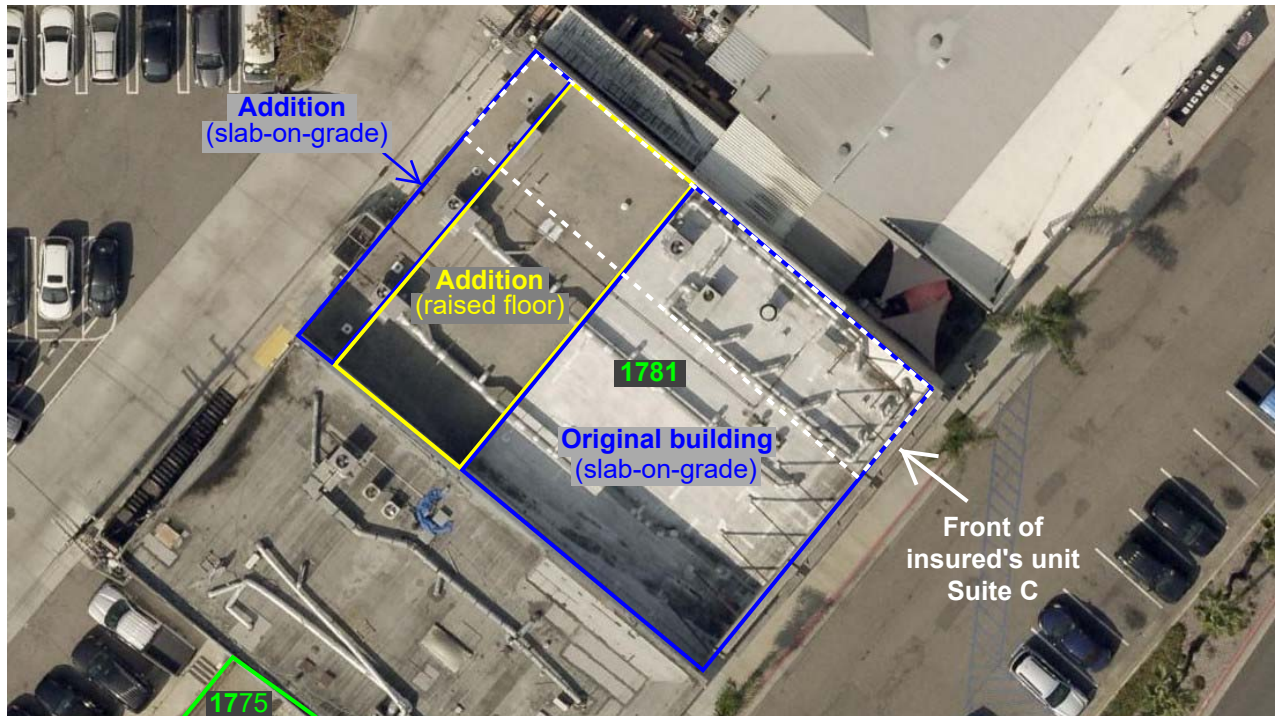
Photo 2: A recent aerial photo with annotations showing the location of the raised floor addition. Note the location of the nearby building 1775 Newport Blvd.

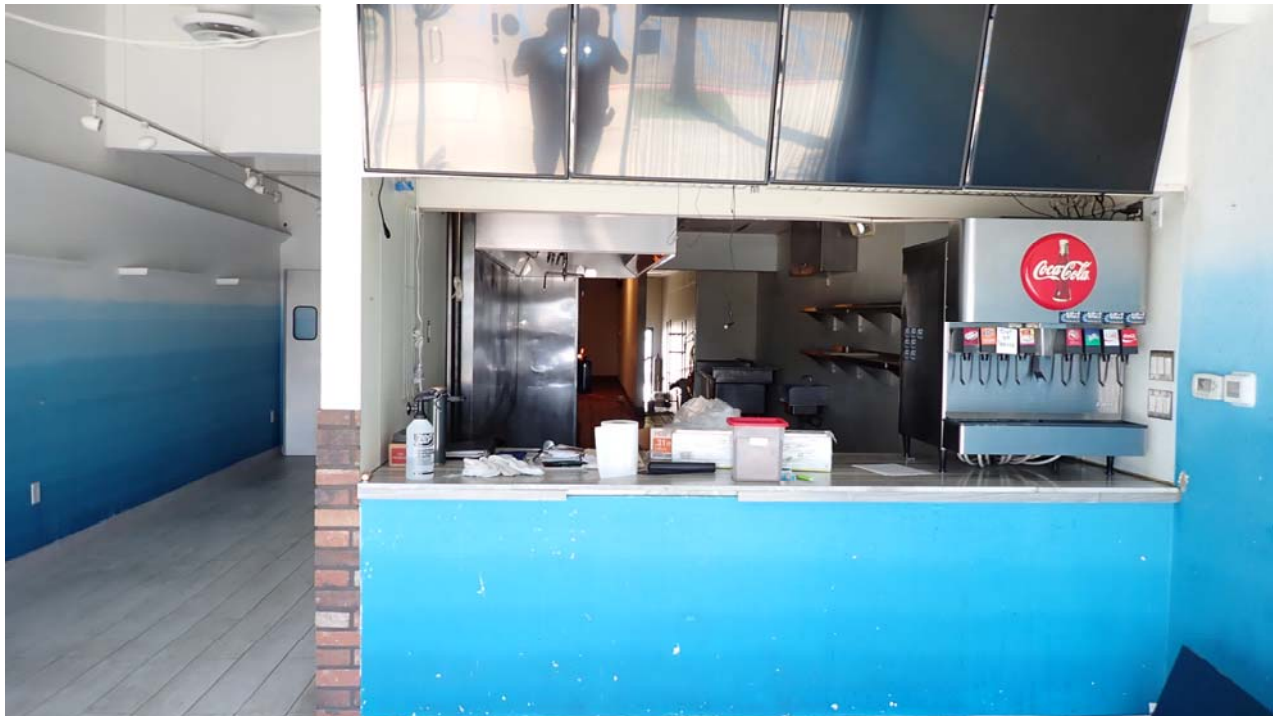
- The customer area and kitchen are located within the front, slab-on-grade portion of the unit (Photo 4).
- In the back, the raised-floor portion of the unit is covered with 6" x 6" square commercial floor tile. Improvements include a walk-in cooler, a sink, and a water heater. The walk-in cooler does not have its own insulated floor, but is installed directly on the tile. The raised floor is uneven and sloping toward the cooler (Photo 5). There is a ramp on the right side of the unit leading down to the rear.
- A short distance away from the cooler toward the front, the floor slope increases near a floor drain (Photos 6, 7). The raised floor feels weak and unsupported near the drain, and the surrounding floor tile is loose and cracked. The cove base has separated from the end of the interior wall line.

Photo 4: A view of the front, slab-on-grade portion of the insured's unit.

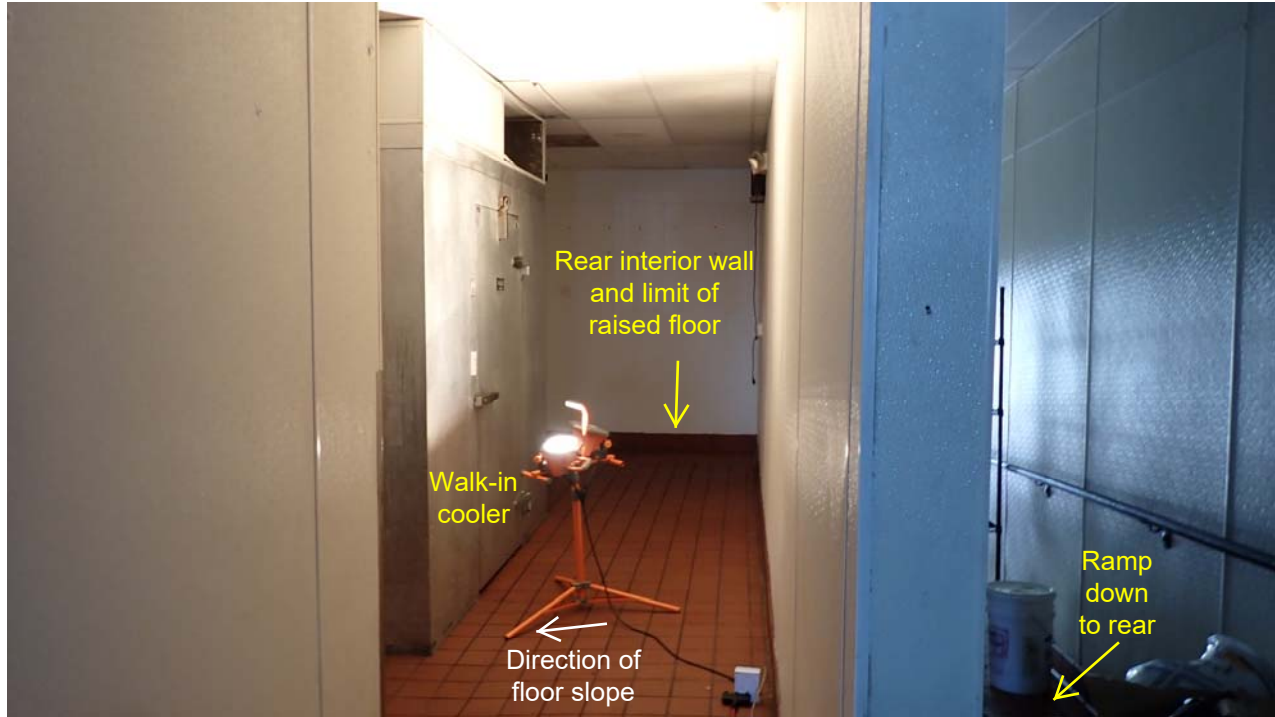
- The walk-in cooler, which was installed over a raised floor, should have been installed with its own insulated floor to prevent condensation and leaking water from reaching the subfloor framing. Also, the subfloor should have been retrofitted with added support beneath the walk-in cooler to prevent any possible framing movement that could cause a breach in the waterproofing. As a result of condensation and leaking moisture from the cooler, the subfloor is currently in very poor condition, with widespread fungal blooms that are likely digesting the fiber of the wood and affecting its strength. Future collapse of the raised floor is possible if the deterioration is allowed to continue. Currently, the weakened subfloor has moved downward and caused floor unevenness and tile cracking. At least one past attempt to repair the subfloor appears to have been made as observed by the presence of relatively newer framing and abundant construction debris in the crawlspace, so it is likely that the subfloor has been undergoing distress for many years.

Photo 5: A view of the rear, raised-floor portion of the restaurant. The floor is covered with 6" x 6" square commercial tile. The cooler, which does not have its own insulated floor, is installed directly on the tile. The raised floor is sloping toward the cooler. There is a ramp toward the rear on the right side of the building.

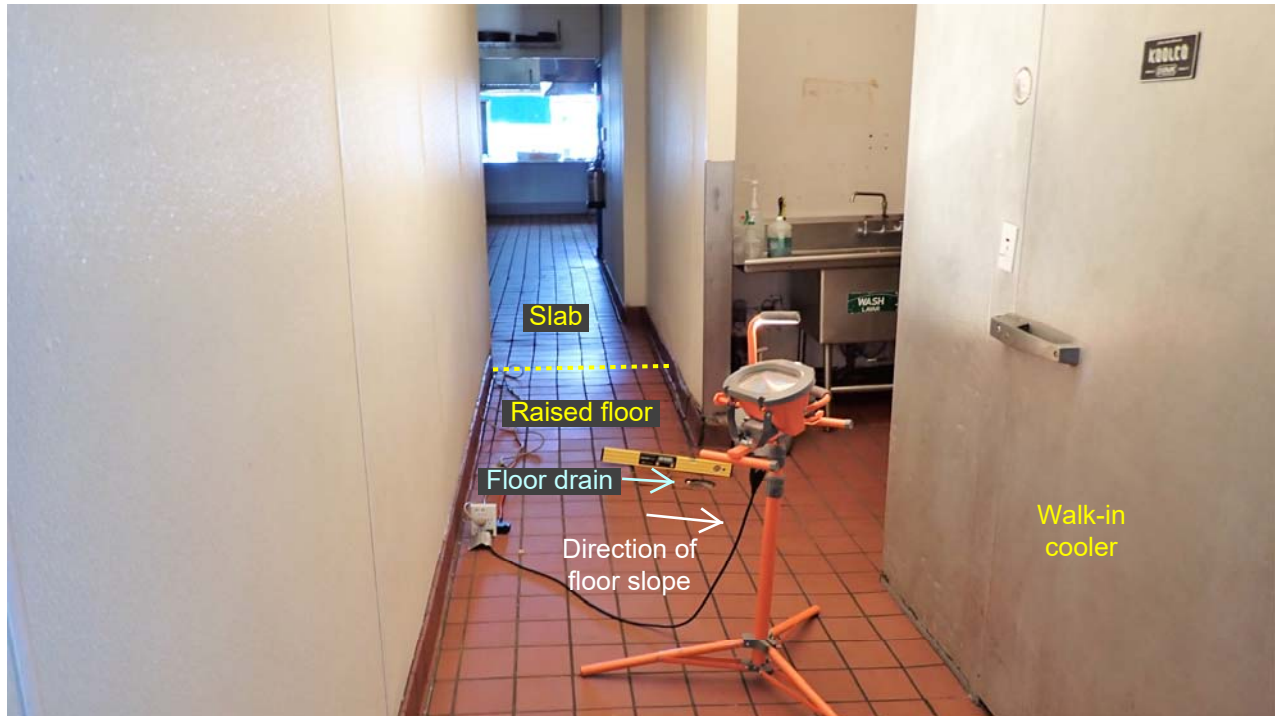
- At the separated cove base, there is older patching with sealant, as well as a grout repair along the bottom of the wall. The damage has reopened since the time of repair (Photo 8).
- In front of the cooler door, the floor is sloping toward the cooler at 2.1% (Photo 9).
- A gap at the corner of the cooler was sealed with spray foam. A few feet away, a large hole in the floor reportedly opened up during tenant improvements next door in 2020 (Photo 10).
- The inside of the cooler does not have its own insulated floor, but is installed directly on top of the floor tile (Photo 11).
- There is a gap between the floor tile and the front wall of the cooler (Photo 12). Gaps were also reportedly sealed at the back of the cooler along the shared wall with Scuba.com. When washing the floor, the water would reportedly drain through the gaps at the back.

Photo 6: A view toward the front showing the walk-in cooler and the sloping floor. The slope of the floor increases near a floor drain.

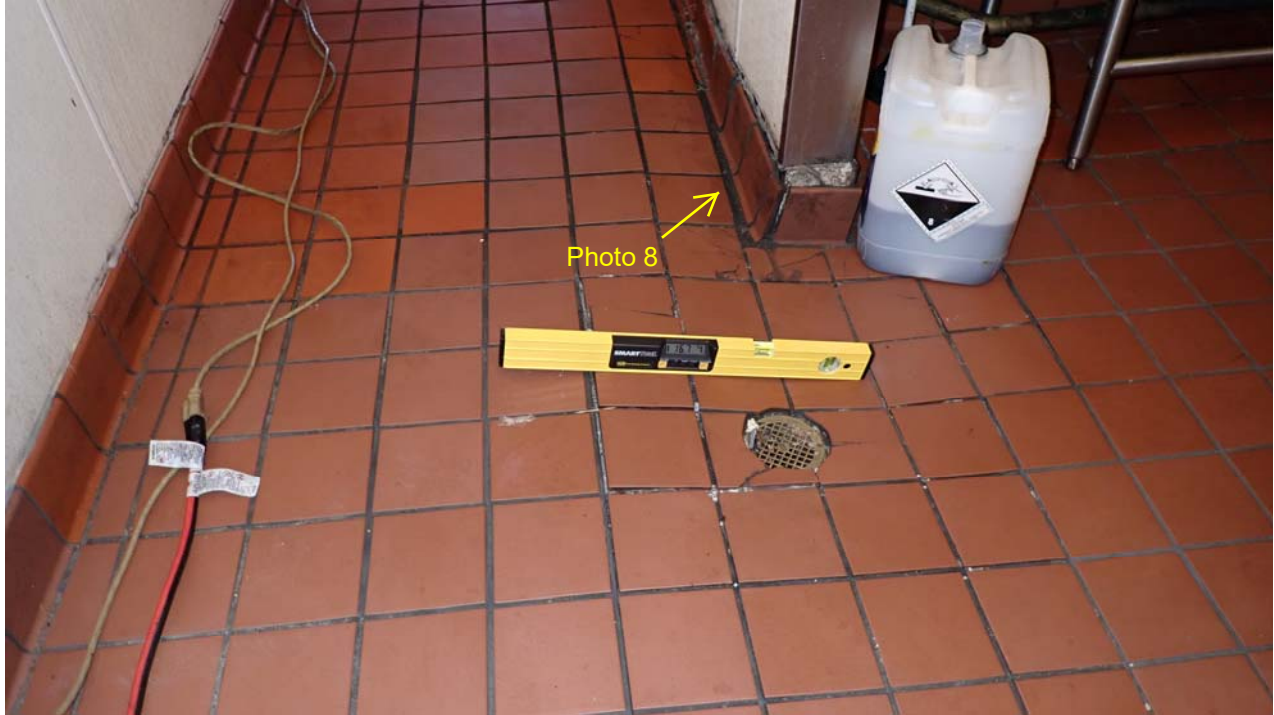
Photo 7: A closer view of the damaged raised floor. The floor feels weak and unsupported near the drain. The tile is cracked and loose surrounding the drain, and the cove base is separating from the end of the interior wall.

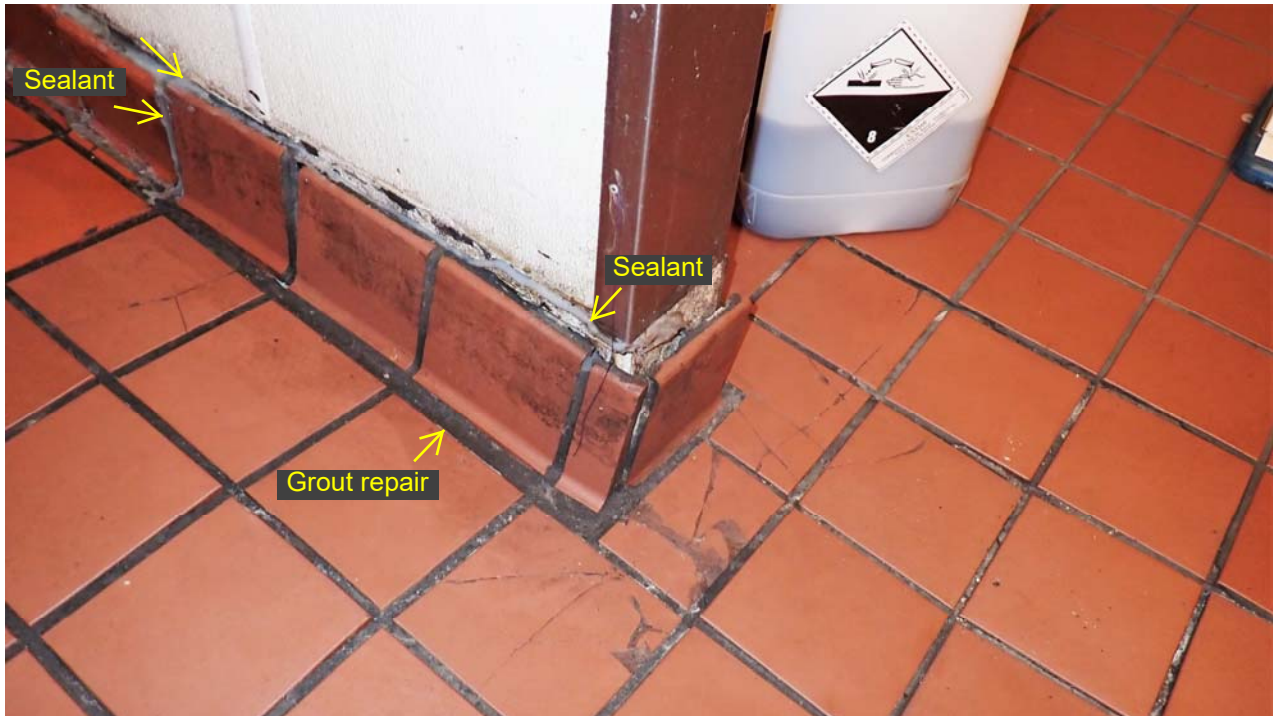
Photo 8: A closer view of the cove base tiles that are separating from the interior wall. Along the tiles, there is an older repair with sealant that has reopened.

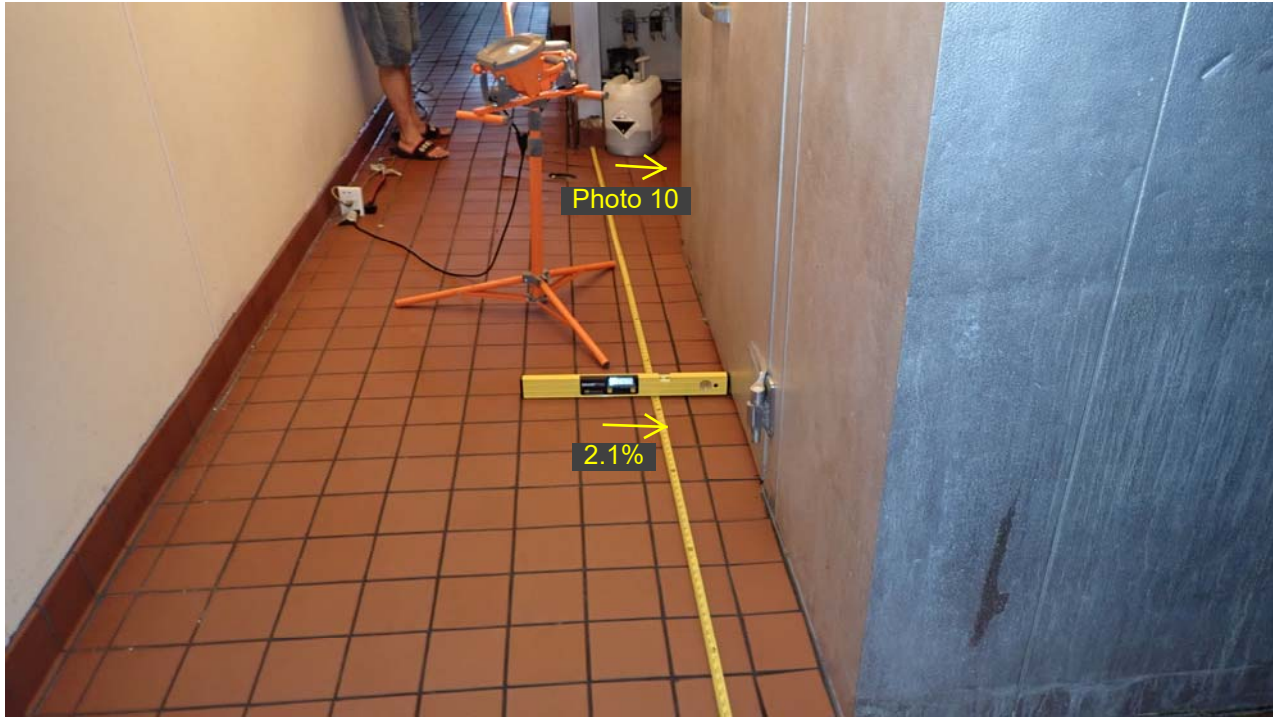
Photo 9: Another view of the tiled floor that is sloping toward the cooler at 2.1%.

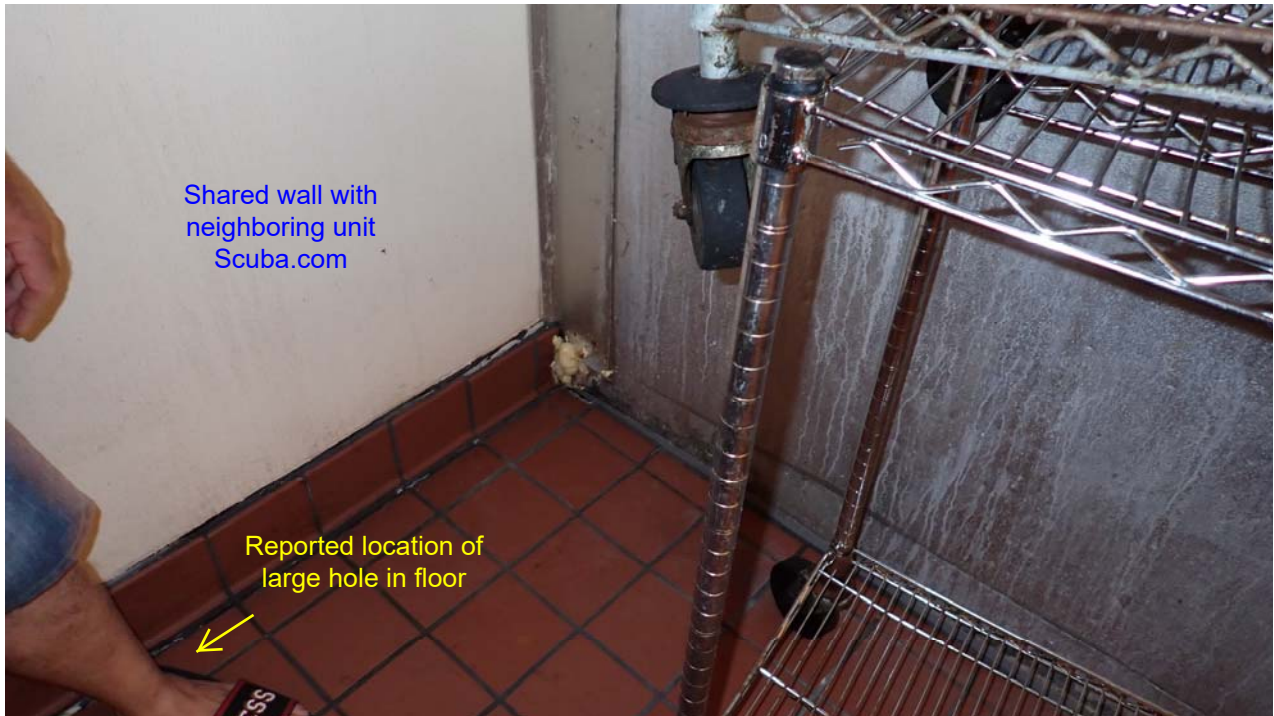
Photo 10: A gap at the corner of the cooler that was sealed with spray foam. Reportedly, a large hole opened up a few feet away during Scuba.com tenant improvements in 2020.

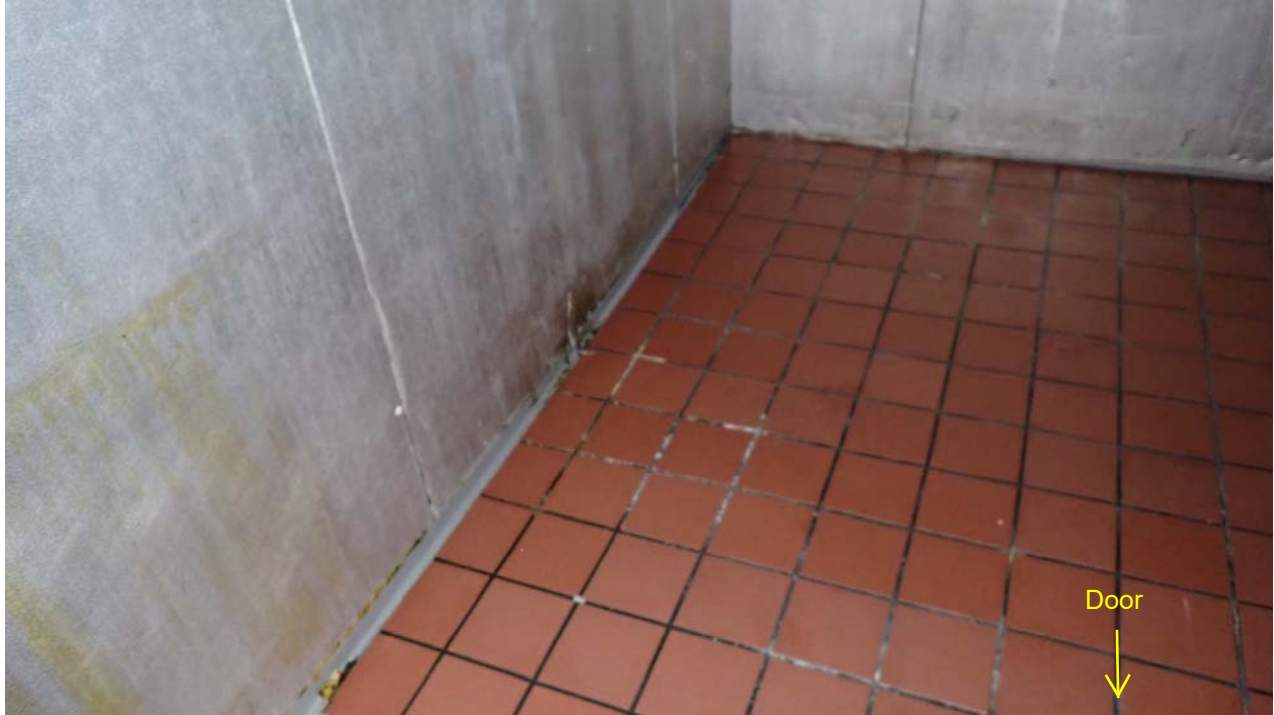
Photo 11: The inside of the cooler, which is installed directly on the tile without its own insulated floor.

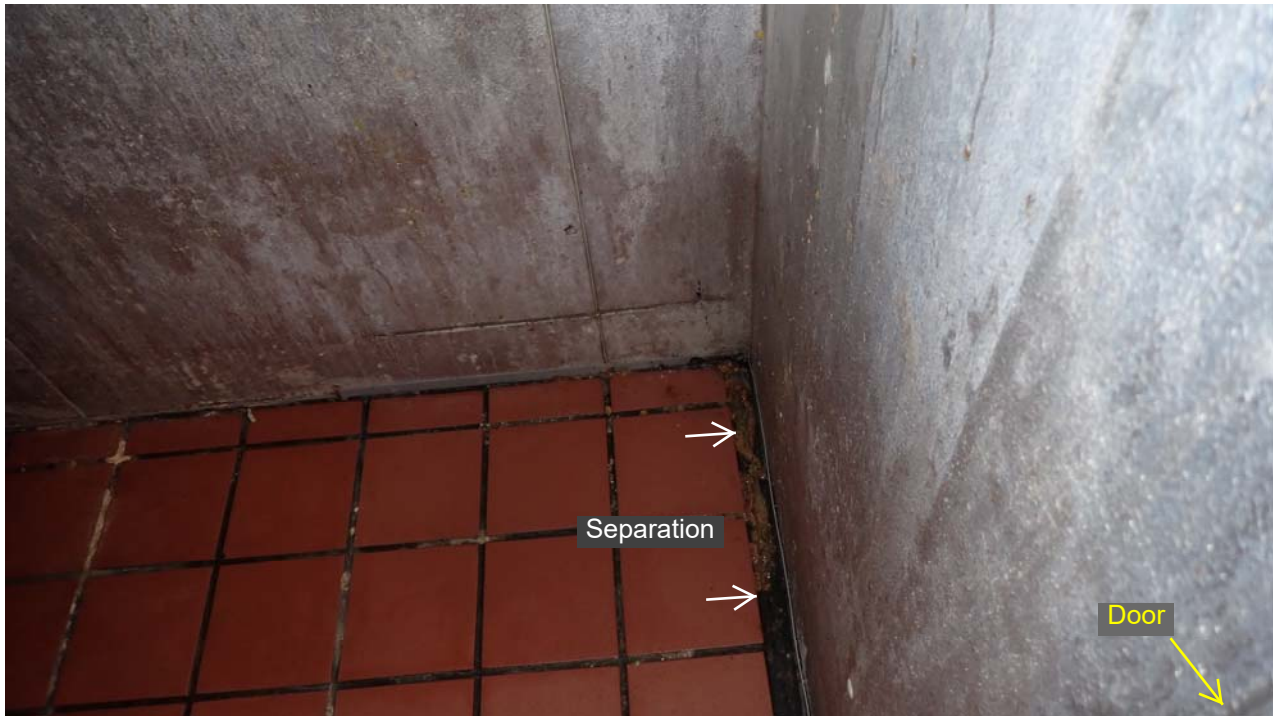
Photo 12: A separation between the tile and the front wall of the cooler.

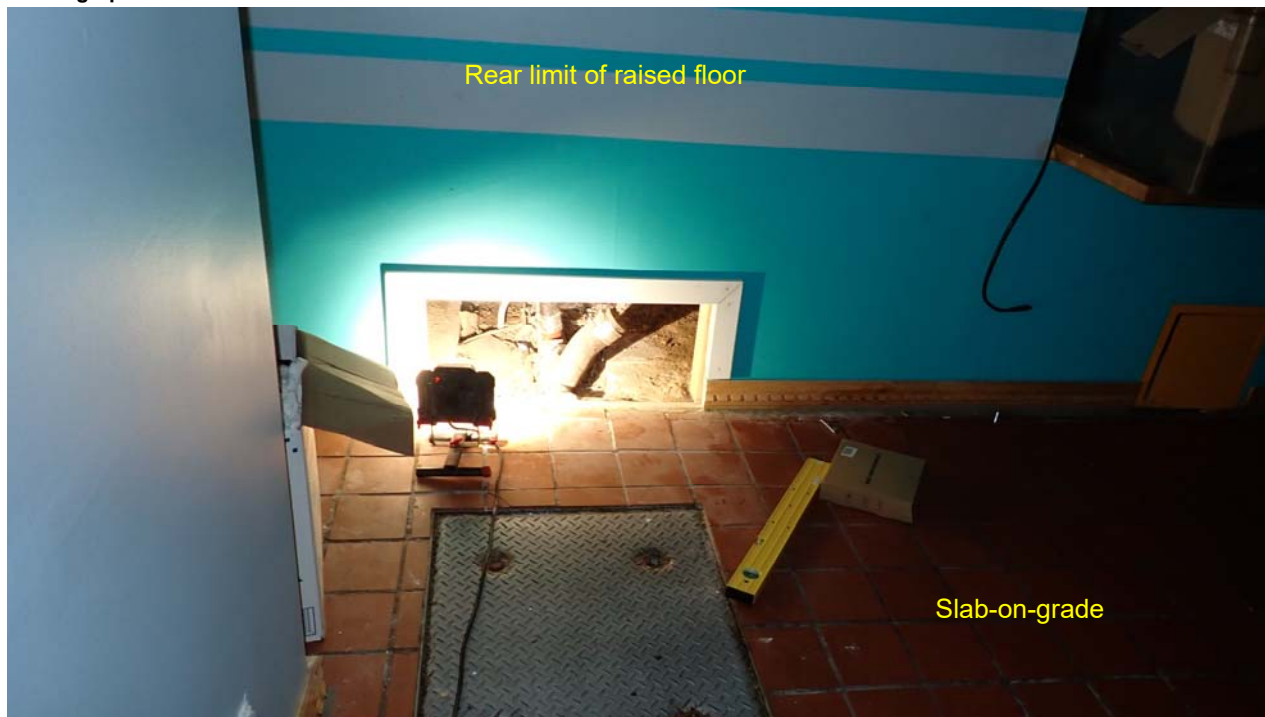
Photo 13: The crawlspace access located at the rear of the raised floor portion of the building.

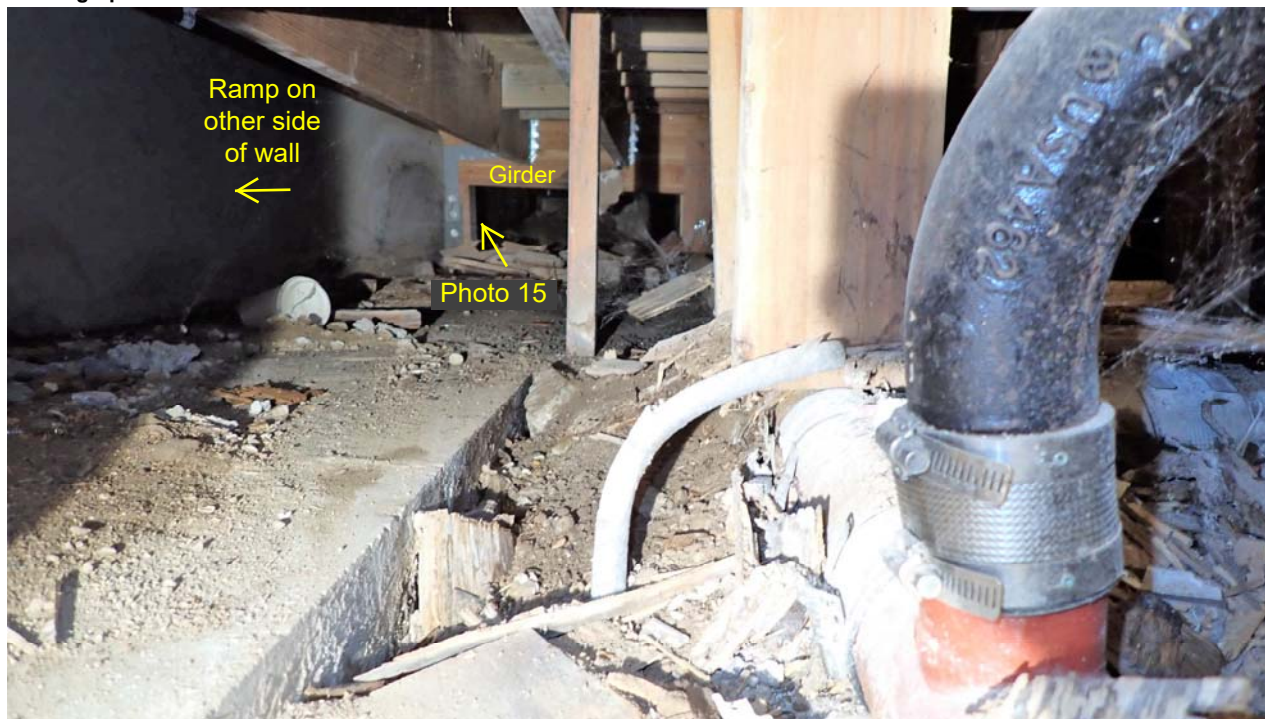
- The crawlspace access is located at the rear of the raised-floor portion of the building (Photo 13).
- Viewing near the access toward the front of the unit, the floor joists run front-to-back and the girders run left-to-right. The floor joists are attached to the girders with joist hangers. The ramp, which runs along the right side of the unit, is on the other side of the wall as indicated (Photo 14).

Photo 14: The crawlspace of the raised-floor viewing from the crawlspace opening toward the front. The floor joists run front-to-back, and the girders run left-to-right. The floor joists are attached to the girders with joist hangers. The ramp shown in Photo 5 is on the other side of the wall.

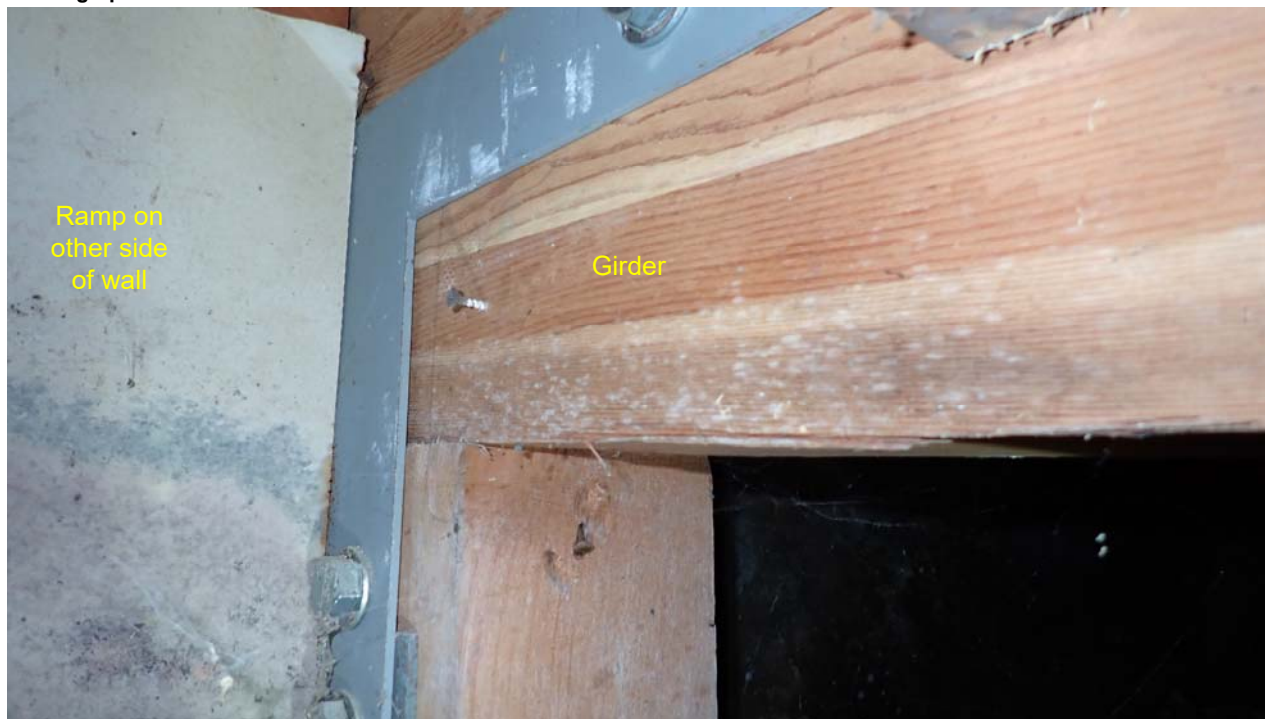
- A girder is supported on a post at the location of the interior wall adjacent to the ramp (Photo 15). This framing appears newer than the original construction of the addition in the mid 1960's. Construction debris was noted throughout the crawlspace.

Photo 15: The girder shown in Photo 14 where it is supported on a post. The ramp shown in Photo 5 is on the other side of the wall. This framing generally appears newer than the construction of the addition in the mid 1960's, and there is construction debris throughout the crawlspace.

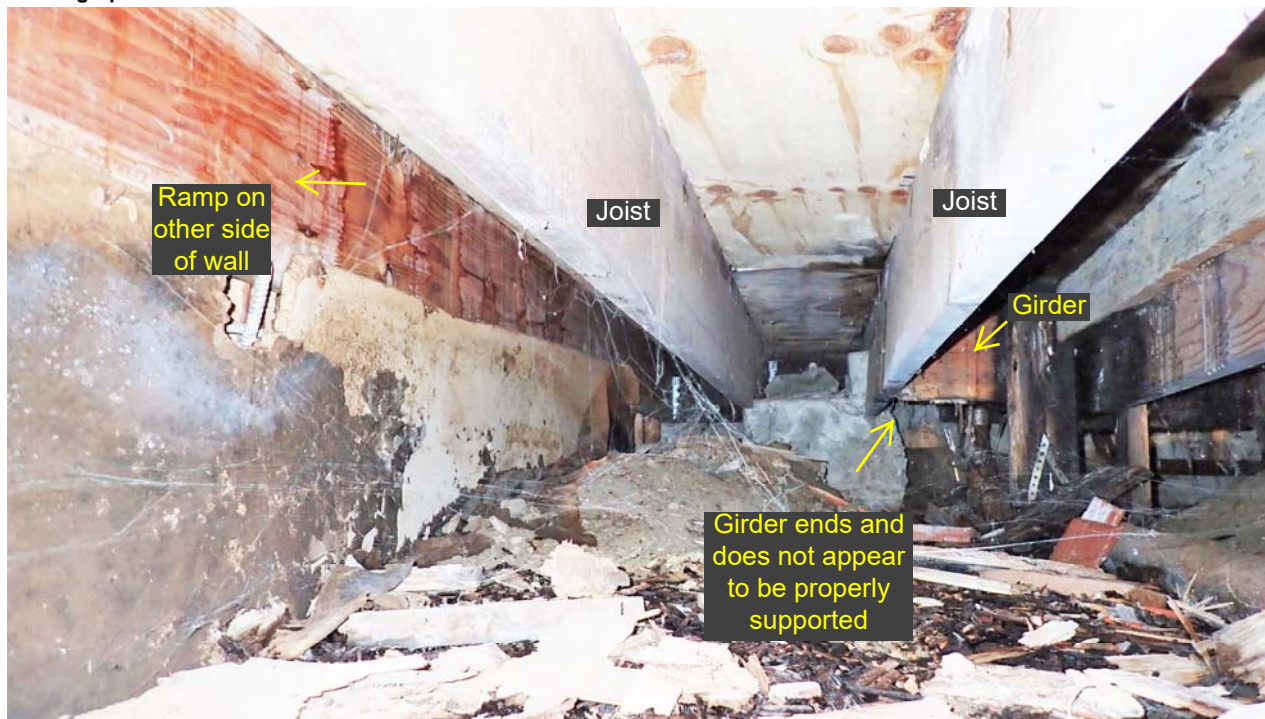
- Moving further toward the front from the girder shown in Photo 15, there is another girder end that appears to be unsupported near the location of the most severe floor deformation. There is abundant wood and tile construction debris in the crawlspace which prevented access to the heavily deformed floor area between the walk-in cooler and the floor drain (Photo 16).

- The area with the most severe raised floor deformation is near the walk-in cooler. As observed from the crawlspace below, a nearby girder appears to be unsupported at its end. This likely led to floor deflection that was aggravated by the weight of the walk-in cooler and all of its contents. The cooler appears to have been in place years before the insured moved into the property.

Photo 16: The crawlspace viewing toward the front just beyond the girder shown in Photos 14 and 15. There is abundant wood and tile construction debris in the crawlspace. Near the area shown in Photo 7, the girder stops and the end does not appear to be supported. Further exploration in the crawlspace was impeded by construction debris.

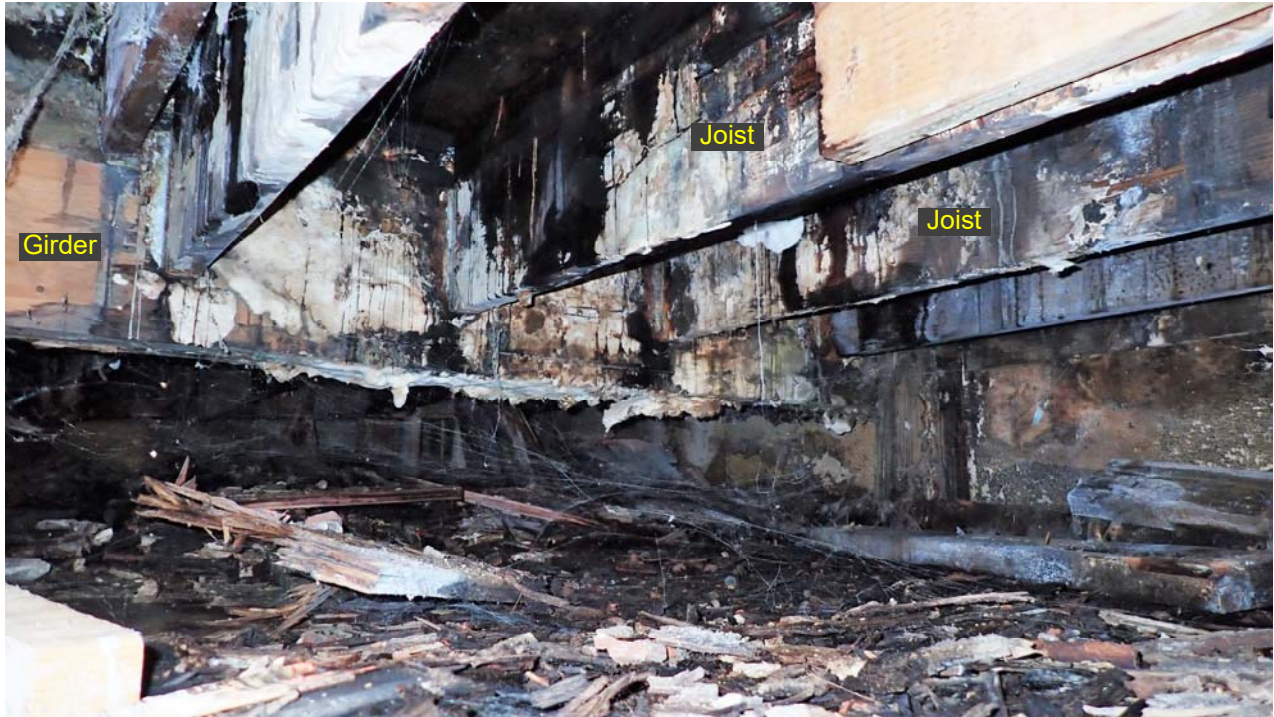
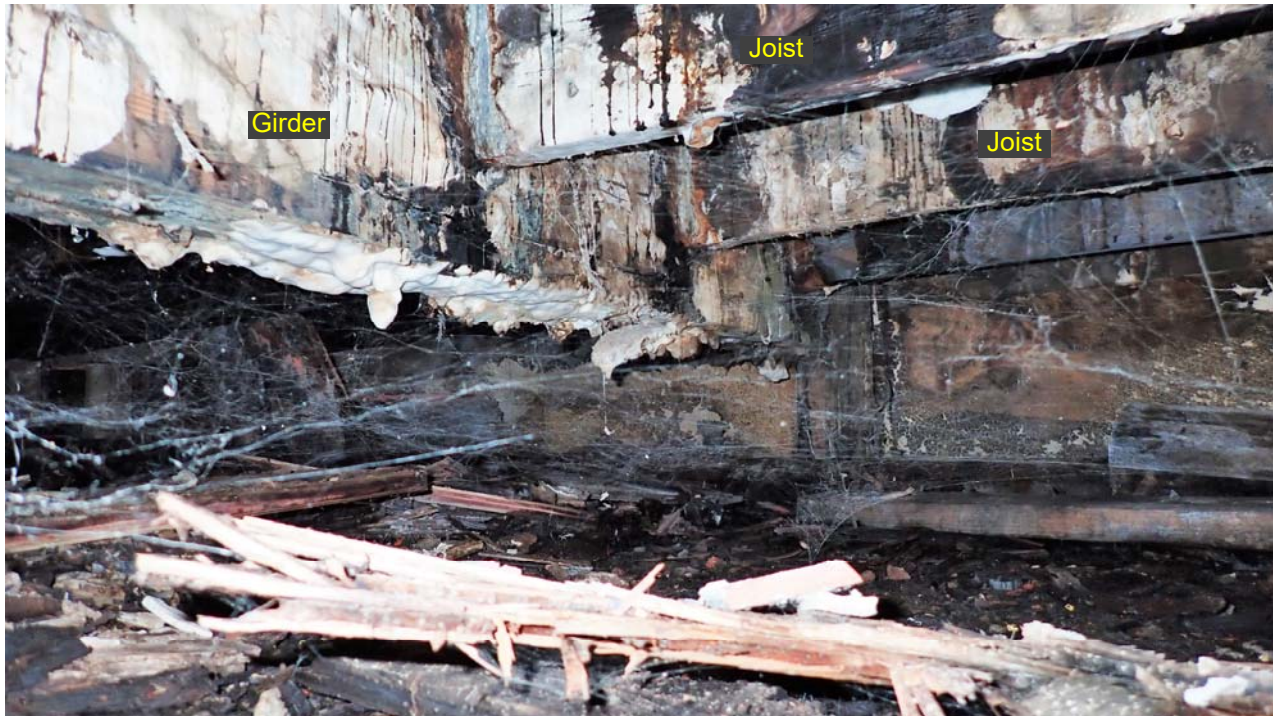
- The subfloor beneath the walk-in cooler is covered with white fungal blooms which have likely caused deterioration and weakening of the floor support framing. A black substance has dripped down on top of the fungus. This may be due to past hot mop waterproofing applied to the floor, or is possibly some other unknown substance (Photos 17, 18).

Photo 17: The framing below the cooler, which has severe white fungal blooms which have likely caused heavy deterioration and weakening of the floor support framing. The black substance, which has dripped over the white fungus, may be due to a past waterproofing attempt, or is some other unknown substance.

Photo 18: A closer view of the subfloor support framing below the cooler.

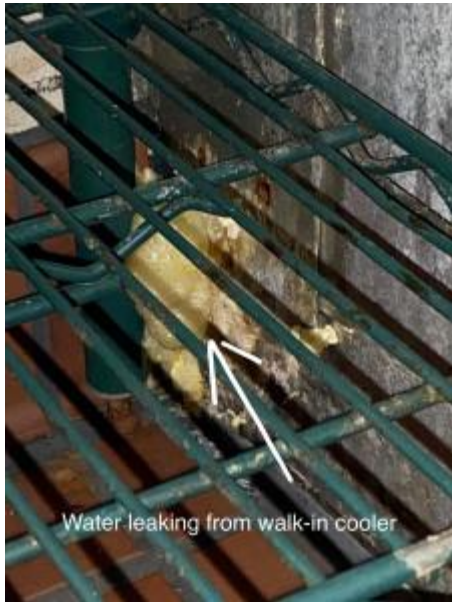
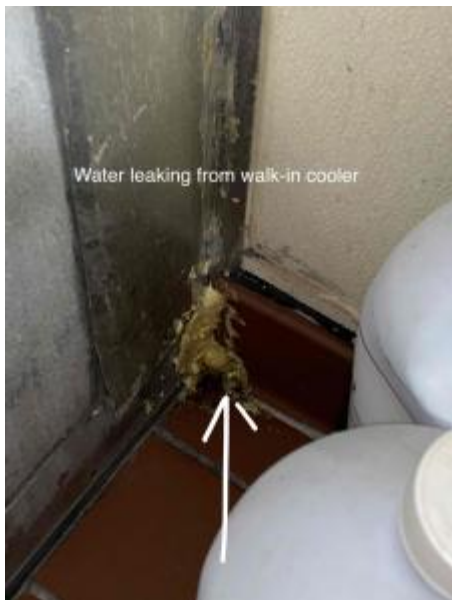
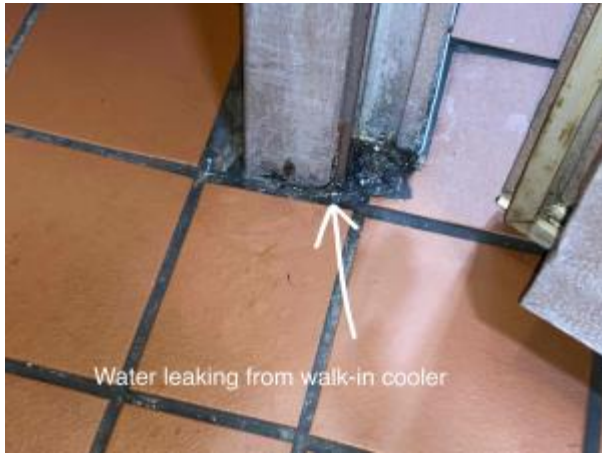
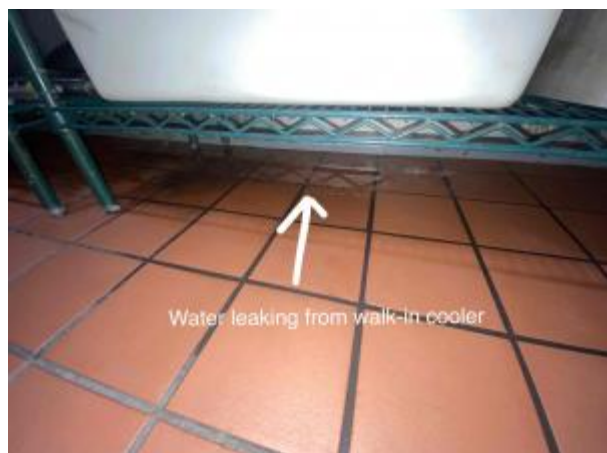
Found no indications of any active pressurized water pipe leaks at this time. Observed pooling water at the base of the walk-in cooler walls. Recommend an appliance technician to test/inspect the walk-in cooler systems in order to determine the source of the pooling water around the walk-in cooler areas.

The evidence of the sinking floor at the areas in question appears to be a result of the leaking walk-in cooler and moisture leaking through the kitchen tile flooring when spraying/washing the kitchen floors.

WATER LEAKING FROM WALK IN COOLER_4

WATER LEAKING FROM WALK IN COOLER_3

WATER LEAKING FROM WALK IN COOLER_2

WATER LEAKING FROM WALK IN COOLER

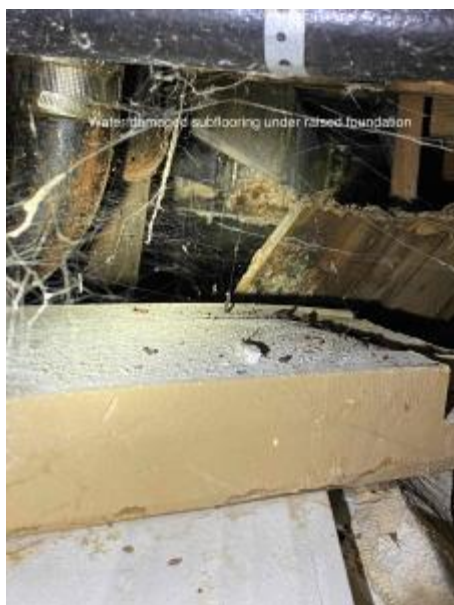
Photo #10

WATER DAMAGED SUBFLOORING UNDER RAISED FOUNDATION

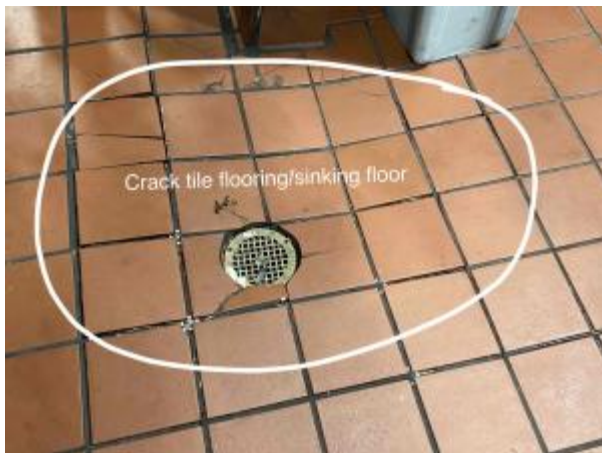
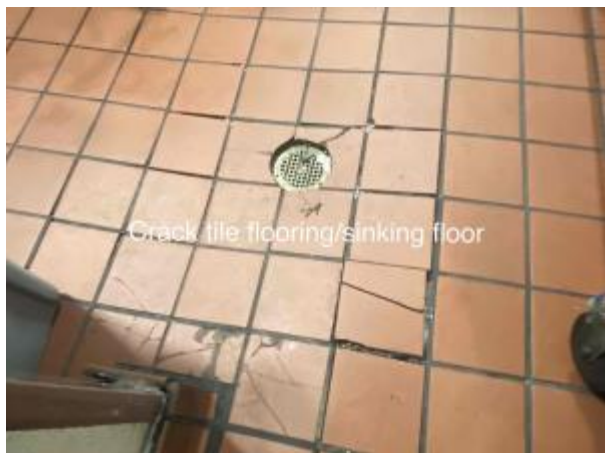
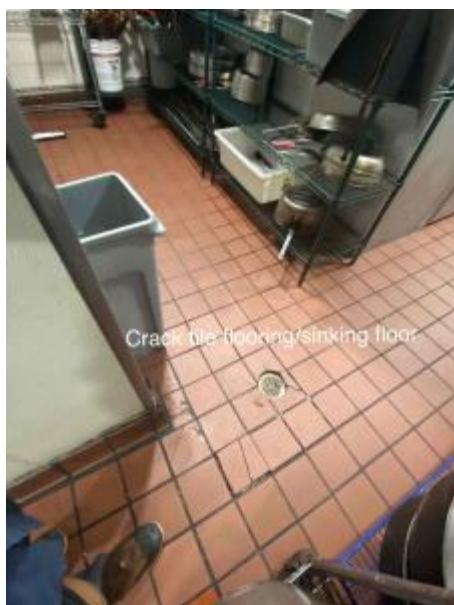
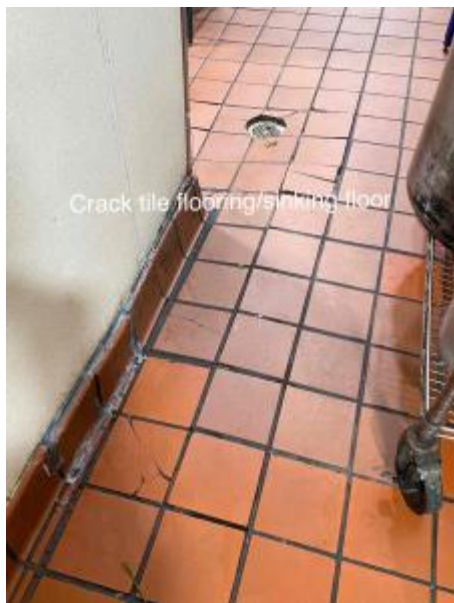
CRACKED TILE FLOORING SINKING_2

CRACKED TILE FLOORING SINKING

CRACKED TILE FLOORING

CRACK TILE FLOORING SINKING FLOOR
